# Elk River Alliance – Cottonwood Restoration Project: Rehabilitation Prescription

**Kefer Ecological Services**

October, 2022

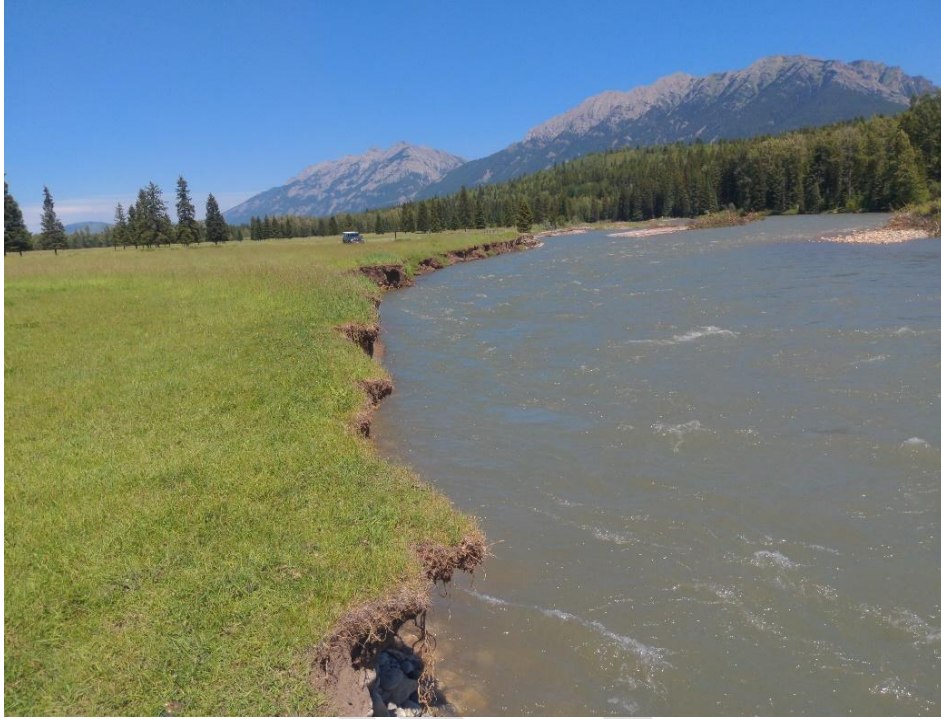
Figure 3. Private property site demonstrating low bank stability and exhibiting no woody vegetation and a strong need for restoration.

- They are devoid of shrubs and trees resulting in decreased bank stability and experiencing some bank erosion along portions of the site (Figures 2 and 3);
- The size and accessibility of the restoration area;
- Relatively flat ground, therefore easier site preparation to conduct; and
- The landowners desire to work with ERA to improve habitat values along the Elk River.

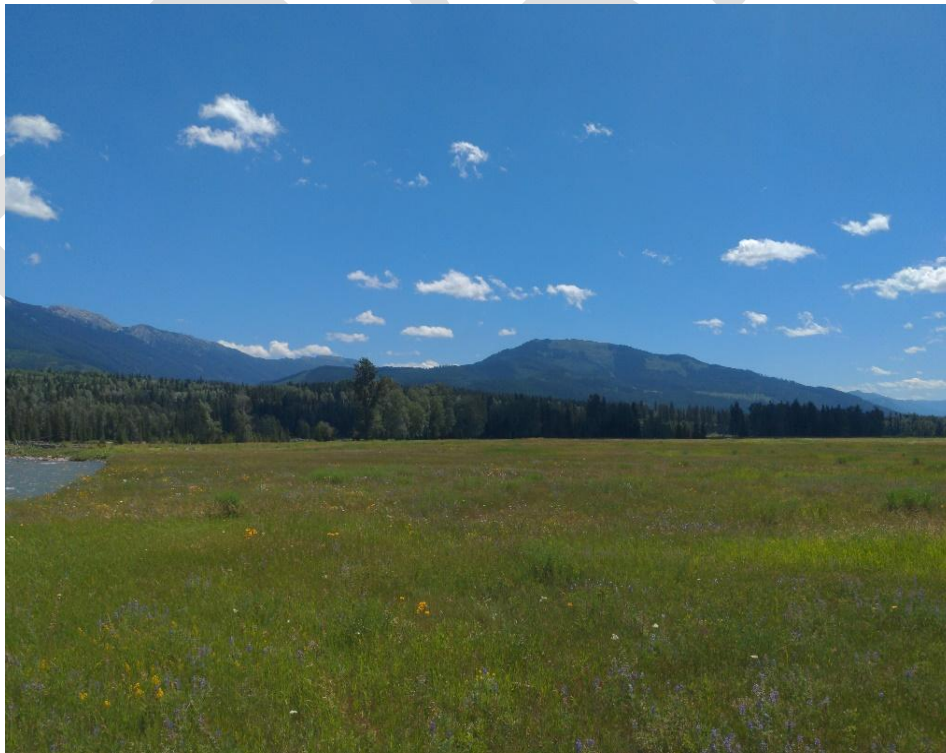
Figure 4. NTBC Big Ranch Conservation Complex rehabilitation site demonstrating current vegetation cover.

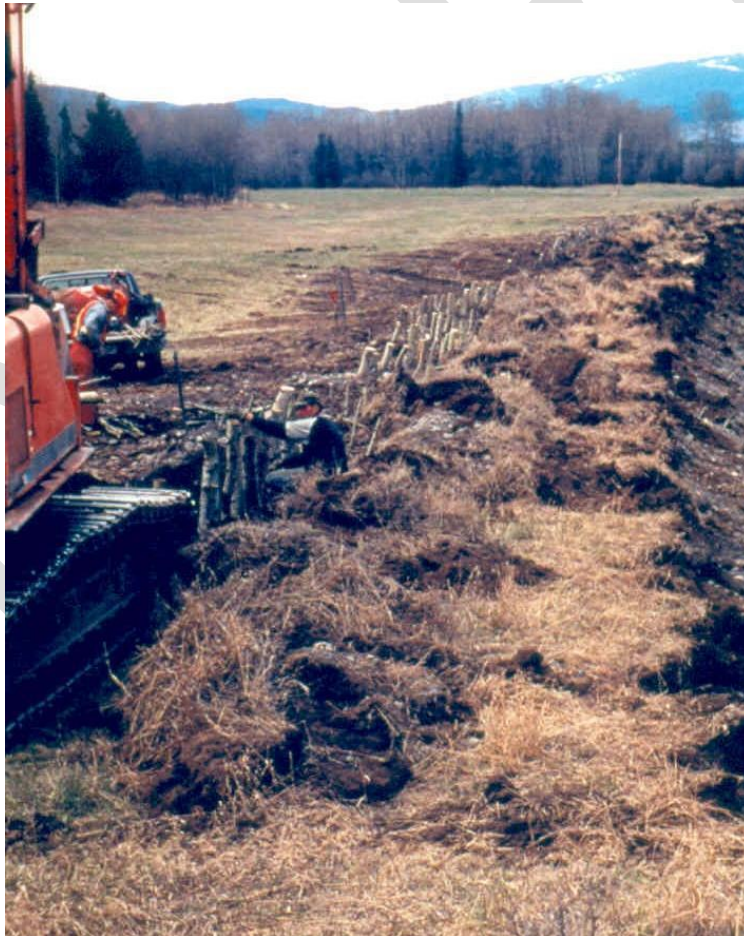
Figure 6. Live palisade method used for streamside restoration. Image shows work conducted by Polster Environmental Services along the Bulkley River (Polster, 2005).

Live palisade is a trench/row style planting technique using cottonwood live stakes<sup>1</sup> that aims to create a dense root network to protect the bank from future erosion (Polster, 2005; Figures 5 and 6). Using an excavator, a trench will be dug 2 – 5 m from the eroding river. Planting away from the bank allows the stream to naturally erode prior to reaching the root network. The trench will be dug down to the water table, approximately 1 m deep, however this is site specific and will be determined by digging a test hole prior to excavation<sup>2</sup>. The trench will be dug in the spring, during freshet, to know the maximum height of the water table. Live stakes will then be planted to capture spring moisture, with the goal that roots will follow the required moisture at the minimum water table height. Collected live stakes (collection methods and storing are discussed in section 5.0), will be approximately 3 m in length to ensure they are planted deep enough into the water table so they can draw water to thrive after planting, as well as leaving a minimum of 1 m above ground. Planting will be spaced every 50 cm to promote the formation of an underground 'fence' (Polster, 2005). Once the live stakes have been installed, the trench will be backfilled using material previously cleared. Over time, as the trees mature, the cottonwood will provide increased shade and leaf litter for the stream as well as large woody debris for habitat (Polster, 2005) and the trapping of sediments. The live palisade will not be fenced (protected) from wildlife herbivory because it will not be cost-effective and is not deemed necessary.

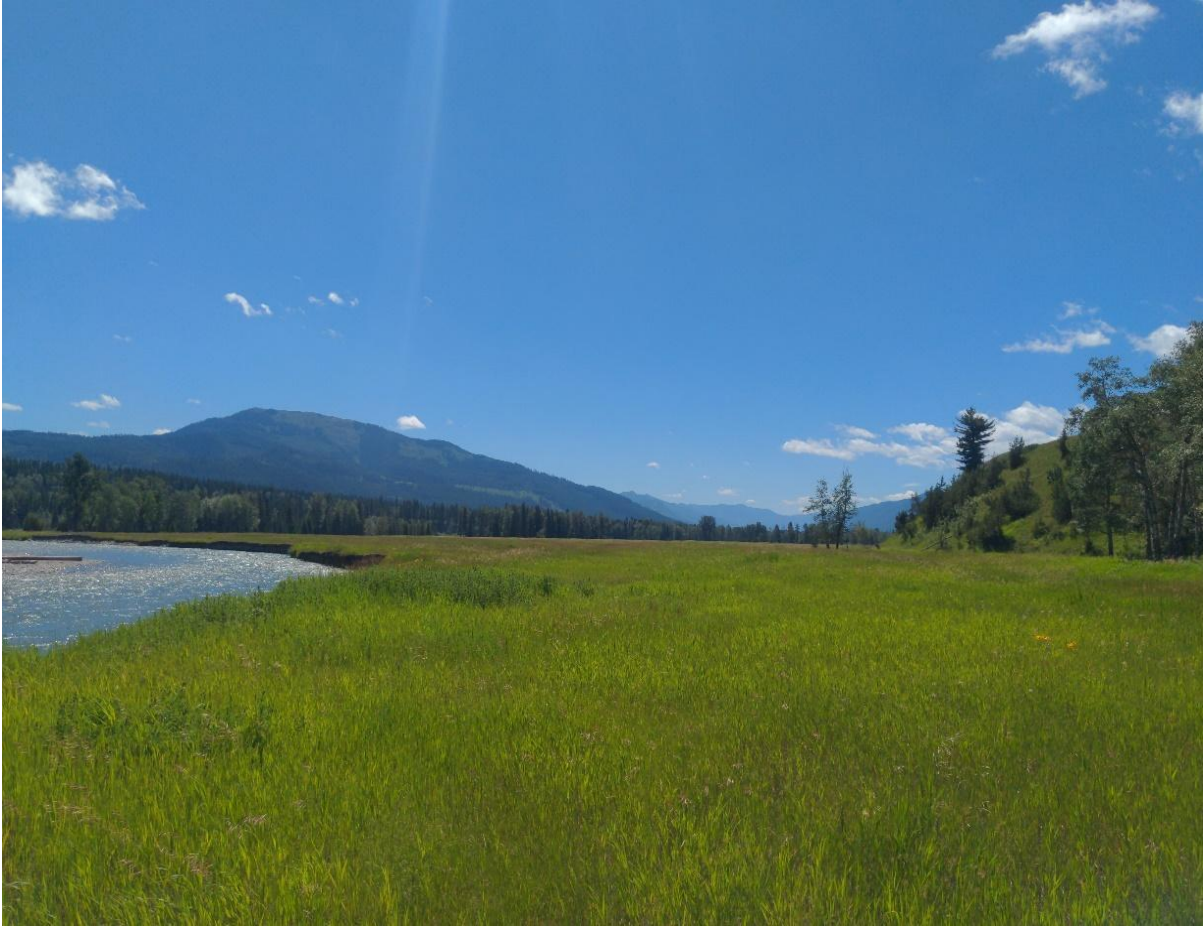
Figure 10. NTBC Big Ranch Conservation Complex rehabilitation site.

Figures 9 and 10 show the rehabilitation site and prescription for the property. Table 2 demonstrates the length or size of each treatment method at the site and the number of live stakes for all identified species necessary for rehabilitation.

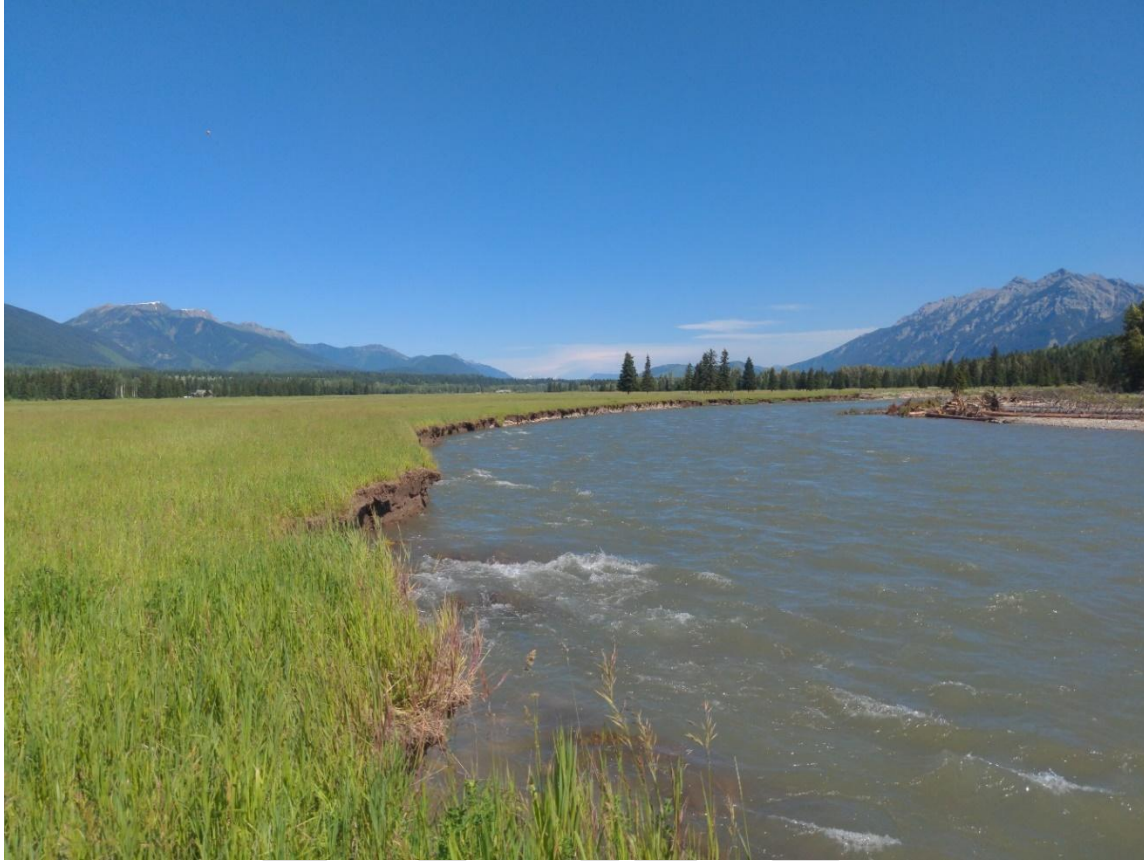
Figure 12. Private property site for proposed rehabilitation work.

Figures 12 and 13 show the rehabilitation site and prescription for the property. Figure 12 specifically demonstrates the lack of woody vegetation, thus making the area susceptible to erosion. Table 3 demonstrates the length or size of each treatment method at the site and the number of live stakes for all identified species necessary for rehabilitation.

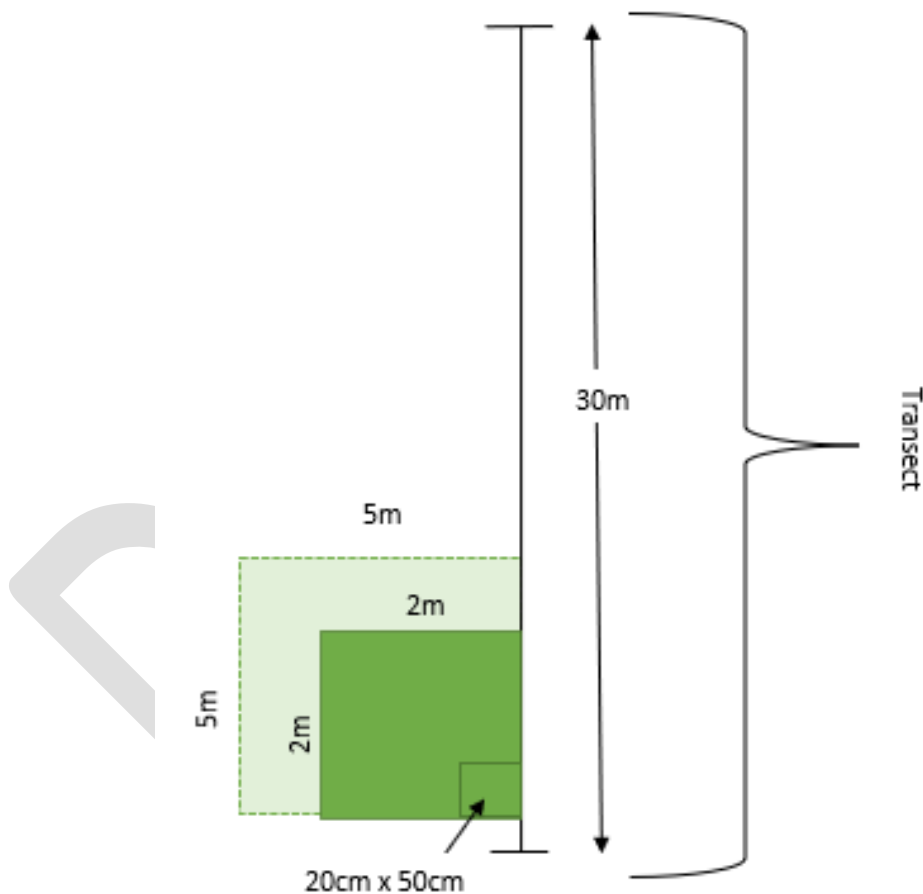
Figure 14. Example of permanent monitoring plot layout

Vegetation plots provide numerical information on species populations and will identify trends at sites to assist with future management efforts. Linear transects 30 m in length will be installed at each treatment method (i.e., live stakes, seedlings, scarified and not, fenced and un-fenced) to gather data for ground cover, graminoid, forb and shrub components of the ecosystem. All sites are relatively flat, however if the transect is located on a slope, it will run parallel with the contour of that slope to avoid any swales. Along the length of each transect, the intercept length for each shrub or tree/live stake that touches or comes within 1 centimeter (cm) of the transect line will be recorded. Recorded information will include if the shrub or tree/live stake is alive or dead, its vigor and height.

To collect understorey data, each transect will incorporate 15 micro-plots placed uniformly along its length. A 4 m<sup>2</sup> (2 x 2 m) micro-plot will be used to estimate the cover of shrubs and trees less than 2 m

tall. A 0.1 m<sup>2</sup> (20 x 50 cm) nested plot within the 4 m<sup>2</sup> plot will be used to estimate the cover of low shrubs (less than 0.5 m tall), forbs and grasses. Ground cover estimates will be observed for total vegetative cover, exposed soil, moss and lichen, rock and coarse woody debris in the 0.1 m<sup>2</sup> nested plot.

To collect tree data, tree plots will be established at the understory transect origin. Tree caliper, height, and vigour will be collected in 5 m x 5 m plots for species over 2 m tall. Photos will be captured at each monitoring plot to capture the structure and composition of each site. Transect start and ends will be permanently marked by rebar (or similar material) for relocation purposes. Data will be collected at years 1, 3, 5, 7, and 10 at a similar time each year to accurately compare information collected. If necessary, monitoring frequency may vary depending on results.
