Lizard Creek Riparian Restoration Pilot Project

Project Type: Habitat-Based Action: Ecosystem/Watershed Restoration/Enhancement

Project Name: Lizard Creek Riparian Restoration Pilot Project

February 12, 2015

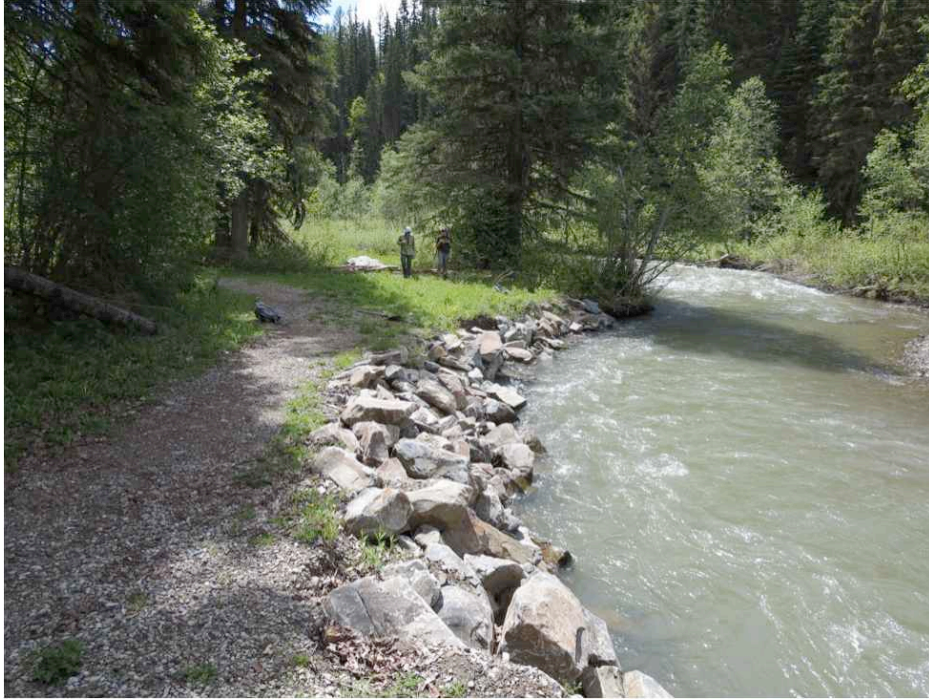
Figure 3 – Photo of Site 1 Rip Rap restoration site, July 2014

Table 1 illustrates the current characteristics of Site 1 Rip Rap. Figure 3 shows a photograph of Site 1 during site assessment. The surface above the bank is flat with a variety of herbs and shrubs in the surrounding area. A list of plant species observed at site 1 is listed below. While the shrubs are beginning to propagate naturally, there is still a large area of exposed sunny area. A few black cottonwood trees were beginning to grow in between the large boulders as shown in Figure 4. The soils are silty clay loam about 4-6 inches deep with very rocky soil below.

In order to increase shade and overhanging riparian vegetation at Site 1, native plant species were planted behind the existing rip rap and in large holes between the rip rap. The plants were sourced from Tipi Mountain Native Plants near Kimberley, BC and included: willow, red-osier dogwood, prickly rose and black hawthorn. The plants were in 1 gallon pales and were planted with extra soil around them to provide nutrients.
