# Lizard Creek: A Unique Habitat for Aquatic Life in the Elk Valley

Fact Sheet submitted by the Elk River Watershed Alliance (ERA), March 31, 2023  
www.elkriveralliance.ca

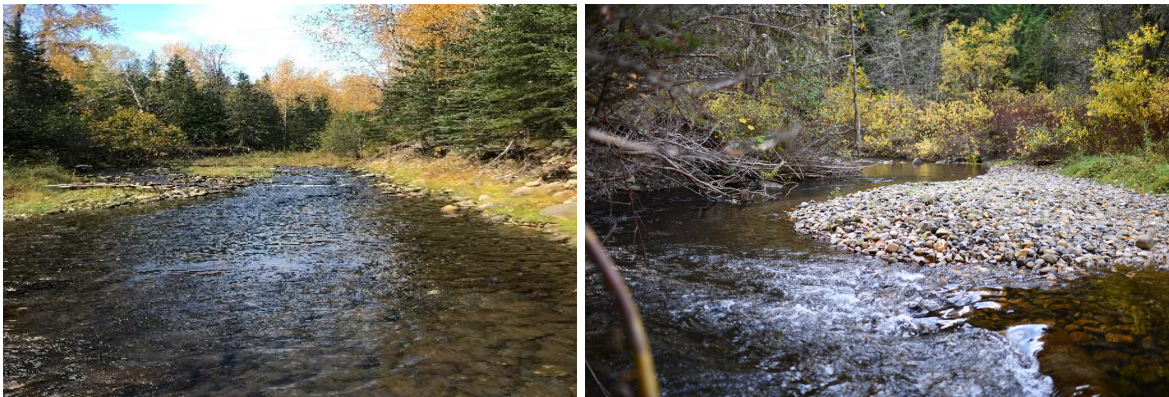
*Lizard Creek CBWM monitoring site close to the mouth (left) and inside Mount Fernie Park (right), ERA 2022.*

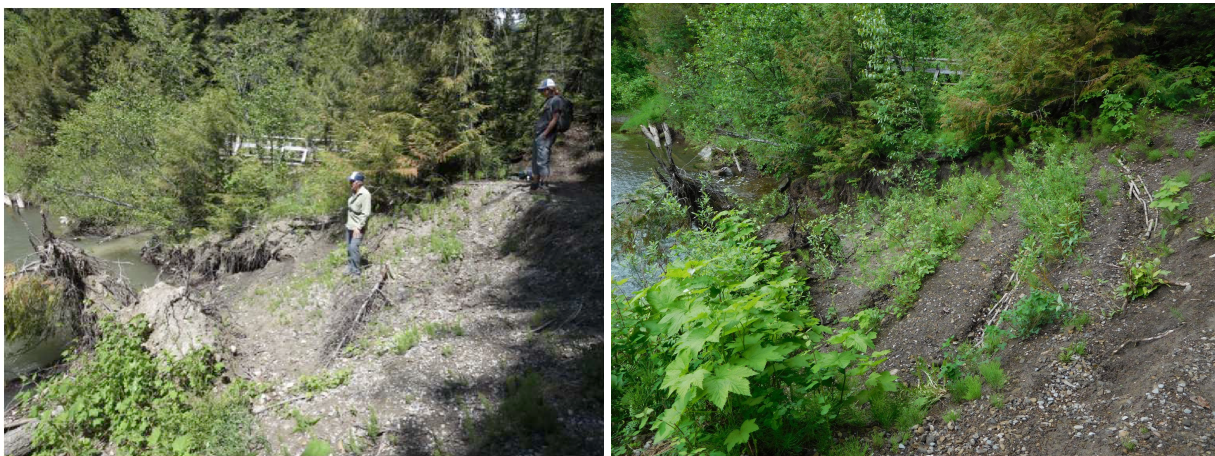
Two significant erosion sites associated with trails, located adjacent to Lizard Creek in Mount Fernie Provincial Park, were restored by the Elk River Alliance in 2014. Initial erosion at one of the sites was likely caused by clearing of vegetation to build the trail. Rip rap was placed to stabilize the stream channel, eliminating riparian habitat. The other site involved a failed slope adjacent to a decommissioned trail which resulted in ongoing erosion and sedimentation.

*Lizard Creek slope failure adjacent to hiking trail (left 2014) and 3 years after ERA's rehabilitation (right 2017)*
